TROUBLE SHOOTING

A Stain Solution Guide

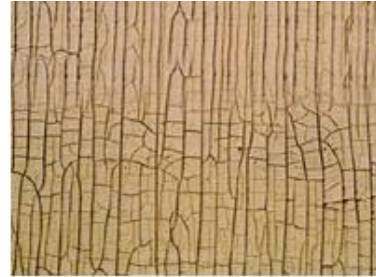
ALLIGATORING:

Patterned cracking in the surface of the stain film resembling the scales of an alligator.

- ❑ Application of an extremely hard, rigid coating, like a solvent-based stain over a more flexible coating, like a water-based stain.
- ❑ Application of a Recoater before the Basecoat is dry.
- ❑ Natural aging of oil-based stains as temperatures fluctuate. The constant expansion and contraction results in a loss of the stain film elasticity.

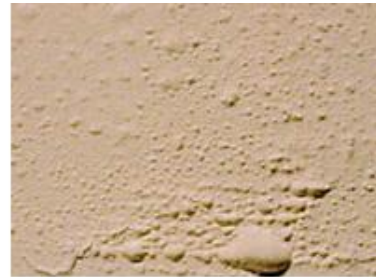
BLISTERING:

Bubbles resulting from localized loss of adhesion and lifting of the stain film from the underlying surface.

- ❑ Residue of water in cracks, crevasses, edges, or corners.
- ❑ Ambient humidity is too high.
- ❑ Improper surface cleaning or preparation. Tiny specs of dirt left on the surface can act as a sponge and hold moisture. When the finish is exposed to the sun (or abrupt changes in atmospheric pressure), moisture expands, and pressure builds up. If the pressure is great enough, blisters form.
- ❑ Wrong thinner or reducer. Use of a fast-dry thinner or reducer, especially when the material is sprayed too dry or at an excessive pressure. Air or moisture can be trapped in the film.
- ❑ Excessive film thickness. Insufficient drying time between coats may trap solvents which escape later and blister the color coat.
- ❑ Contamination of compressed air lines. Oil, water or dirt in lines.
- ❑ Incompatibility of the materials.

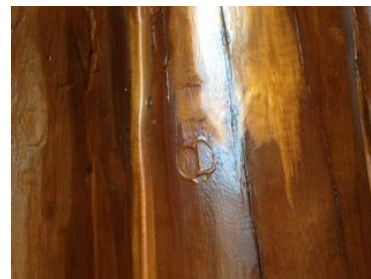
BUBBLING:

There are two things that make a product form bubbles on the surface after a product is applied. One is too much moisture in the wood that wants to escape. The other involves the use of linseed oil in the former finish.

- ❑ Water trapped behind finish.
- ❑ All oil-base products have some form of linseed oil in them.
- ❑ Processed linseed oil - more refined, more pure, dries quicker, yellows much slower and is more expensive to add to product.
- ❑ Non-processed linseed oil (raw, cold pressed) – less refined, more impurities, very slow dry time, yellows much quicker and is less expensive to add into product.
- ❑ All processes above will lead to bubbling of the newly applied product.

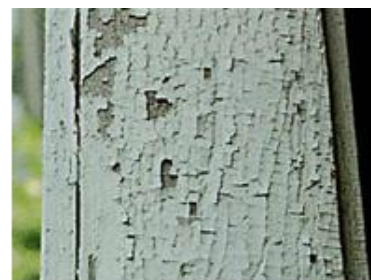
CRACKING / FLAKING:

This involves the splitting of a dry stain film through at least one coat, which will lead to complete failure of the stain. Early on, the problem appears as hairline cracks; later, flaking of stain chips occurs.

- ❑ Water is allowed to soak into wood through cracks. When sun heats this moist surface the finish loses its bond and is pushed away from the wood.
- ❑ Staining under cool or windy conditions that make latex stain dry too fast.
- ❑ Over thinning the stain or spreading it too thin. Poor surface preparation, especially when the stain is applied to bare wood without priming.

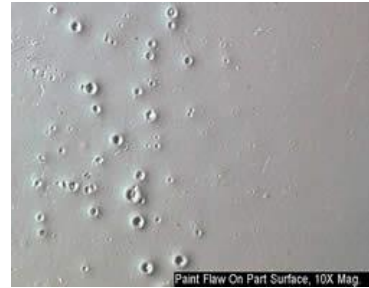
FISH EYE:

A fish-eye is caused when there is some contamination (oil, silicone, etc.) on the surface of the wood before a stain is applied. When the stain is applied over the contamination it will be repelled from the area with the contamination (think oil and water). This causes a little circle with no stain on it, known as a fish-eye.

- ❑ Effects of the old finish or previous repair. The old finish or previous repair may contain excessive amounts of silicone from additives used during their application. Usually wiping with a solvent will not remove embedded silicone.
- ❑ Improper or insufficient surface cleaning or preparation. Many waxes and polishes contain silicone--the most common cause of fish-eyes. Silicones adhere firmly to the stain film and require extra effort for their removal. Even small quantities found in sanding dust rags can cause this type of failure.
- ❑ Contamination of air supply by water, oil, or silicon.
- ❑ Oil, wax, grease, or silicone contamination of wood surface.
- ❑ Use of silicone-containing polishes or aerosol sprays in proximity to the stain area.

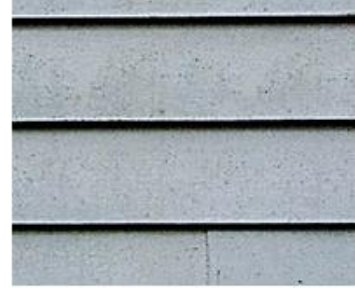
MILDEW:

Black, gray, or brown areas of fungus growth under the surface of stain or caulk.

- ❑ Forms most often on areas that tend to be damp and receive little or no direct sunlight (walls with a northerly exposure and the underside of eaves are particularly vulnerable).
- ❑ Failure to properly prep bare wood thoroughly before staining.
- ❑ Staining over a substrate or coating on which mildew has not been removed.

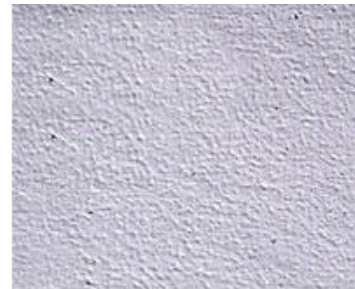
ORANGE PEEL:

Resembling the skin of an orange, it is an uneven texture of the stain. Generally, it is caused by inadequate spraying techniques along with the lack of back-brushing.

- ❑ Wood not sanded or prepared thoroughly.
- ❑ Improper gun adjustment and techniques. Too little air pressure, wide fan patterns or spraying at excessive gun distances causes droplets to become too dry during their travel time to the work surface and they remain as formed by gun nozzle.
- ❑ Extreme temperature. When air temperature is too high, droplets lose more solvent/water and dry out before they can flow and level properly.
- ❑ Improper flash or recoat time between coats. If first coats are allowed to become too dry, solvent in the stain droplets of following coats will be absorbed into the first coat before proper flow is achieved.
- ❑ Too high viscosity.
- ❑ Low application temperature.
- ❑ Materials not uniformly mixed. Many finishes are formulated with components that aid coalescence. If these are not properly mixed, orange peel will result.

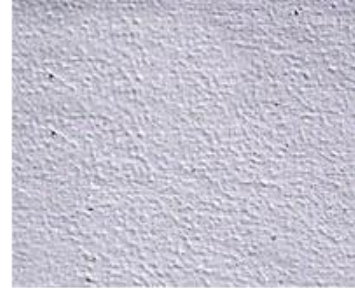
PEELING:

This is caused by the loss of adhesion of the stain due to poor preparation. Where there is a Basecoat and Recoater, or multiple coats of stain, peeling may involve some or all coats.

- ❑ Poor sanding of wood.
- ❑ Surface temperature was too low/too high when applying the finish system.
- ❑ Improper cleaning or preparation. Failure to remove sanding dust and other surface contaminants will stop the finish coat from coming into proper contact with the wood.
- ❑ Failing to remove mill glaze because of improper cleaning and sanding of wood.
- ❑ Materials not uniformly mixed.
- ❑ Film was too dry when the masking tape was removed.
- ❑ Flash times too short due to wind, too cool OR too warm of the surface temperature.
- ❑ Condensation on wood due to temperature changes.

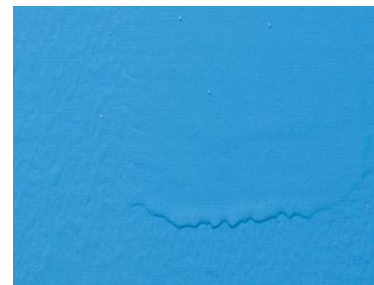
SAGGING:

Downward "drooping" of the stain film immediately after application resulting in an uneven coating.

- ❑ Application of too heavy a coat of stain.
- ❑ Application in excessively humid and/or cool conditions.
- ❑ Application of over-thinned stain.
- ❑ Staining over a glossy surface, which does not provide enough of a profile to which the coating can adhere to.
- ❑ Staining over a surface contaminant.

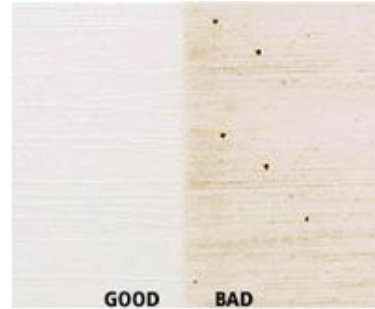
TANNIN STAINING:

It is a brownish or tan discoloration on the stain surface due to migration of tannins through the stain film. Typically occurs on "staining woods," such as redwood, cedar and mahogany, or over stained knots in certain other wood species.

- ❑ Excess moisture escaping through the exterior walls, which can carry the stain to the stain surface.
- ❑ Failure to adequately prime and seal the surface before applying the stain.
- ❑ Use of a primer that is not sufficiently stain resistant.

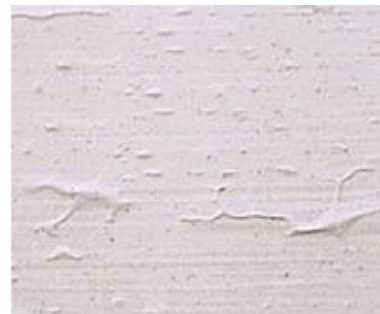
WRINKLING:

Wrinkling is a rough, crinkled surface that occurs when stains form a "skin" on a wood surface.

- ❑ Stain applied too thickly (more likely when using alkyd or oil-based stains).
- ❑ Staining a hot surface or in very hot weather.
- ❑ Exposure of uncured stain to rain, dew, fog, or high humidity levels.
- ❑ Applying A topcoat of stain to insufficiently dried first coat. Staining over contaminated surface (e.g., dirt or wax).
